Case Study

Reducing Throughput To Match System Needs

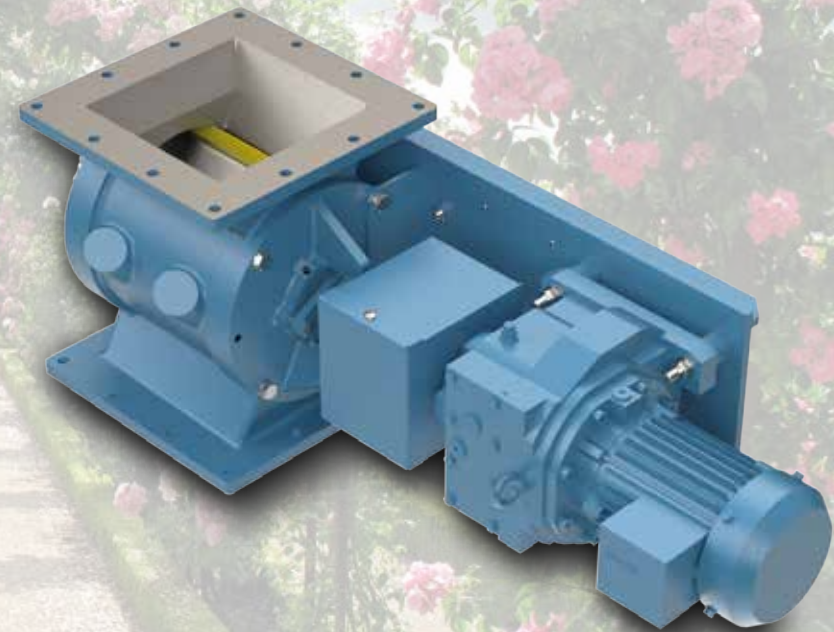
- Working with our technical team, we were able to provide a solution that fulfilled both requirements set by the customer. The addition of a variable speed motor and a rotor reduced to 50% capacity lowered the throughput from 6 m³/hr down to the specified 2 m³/hr while also maintaining the hygiene levels required for the application.

- To provide a Rotary Valve that would meet the required throughput of just over 2 m³/hr while matching the 200mm square connection of the cyclone below.

- The solution provided the correct throughput without needing to make transitions to fit the existing connections, avoiding additional cost.
