Case Study

Enhanced Hygiene with Kleanloks

Enhanced Hygiene with Easy Cleaning

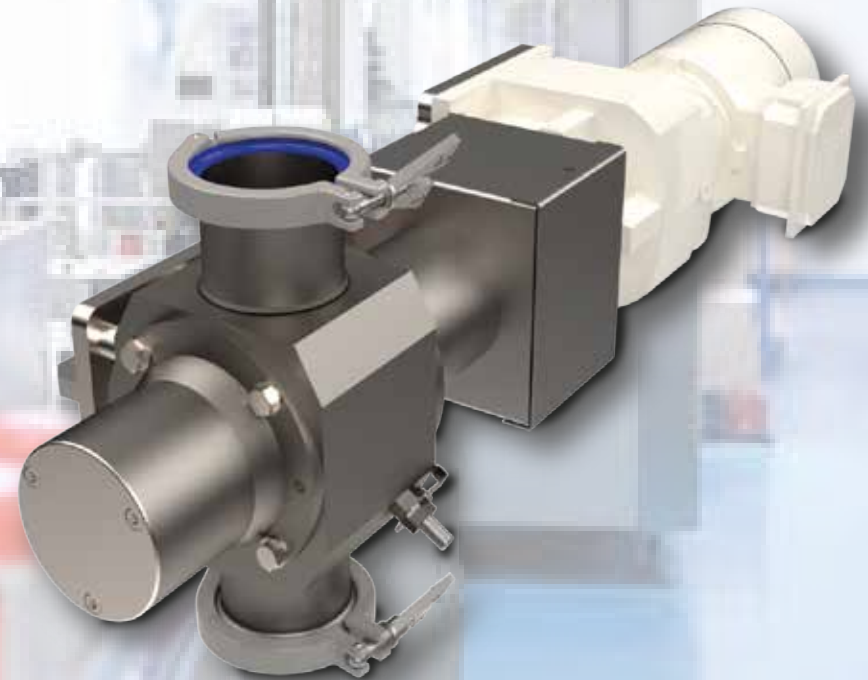
- Given the quantity and size of the capsules, our 75mm Kleanlok was the perfect fit. Our in-house design team developed a solution that would allow for easy installation and removal. Seamlessly incorporating tri-clamp tubes at the inlet and outlet of the valve allowed the valve to be quickly and easily removed from the system without the need for hand tools to remove traditional flange fixings.

- A hygienic valve that allows for the rotor or the complete unit to be removed for cleaning as needed.
